Home Inspection Report

Year Constructed: 1983
Square Feet: 1,105
Type: Single Family Home
Bedrooms: 3
Bathrooms: 2

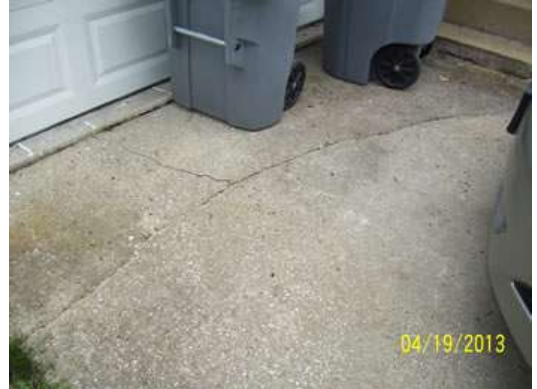
Driveway

- Several moderate to large cracks in concrete.

The driveway had some common moderate to large cracking that is consistent with its age. Suggest sealing all cracks to prevent moisture penetration and further deterioration.

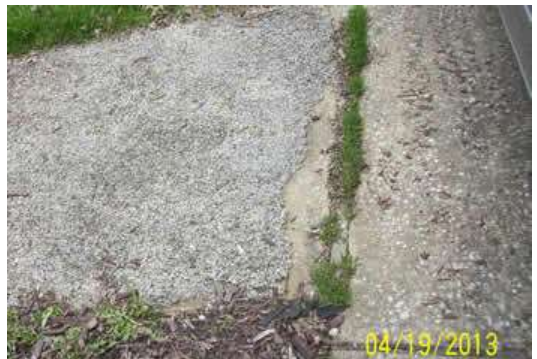
Sidewalk / Walkway (Front)

It appears that the front walkway is concrete with a layer of asphalt over top of it. It is possible that this was done because of significant spalling or cracking of the underlying concrete. The walkway is in serviceable condition.

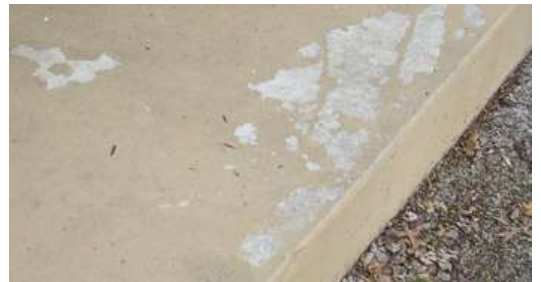
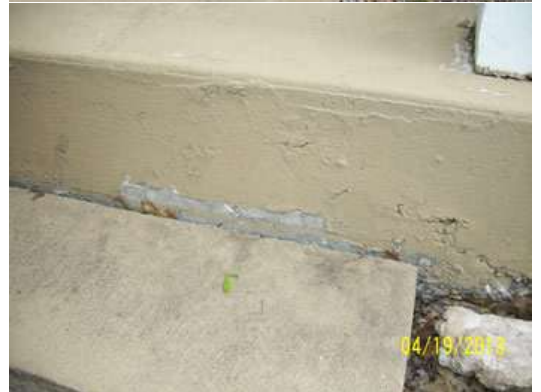
The paint on both the concrete porch and railing is peeling and should be rehabilitated. The single concrete porch step is settling away from the porch itself and the gap should be sealed to avoid moisture intrusion.

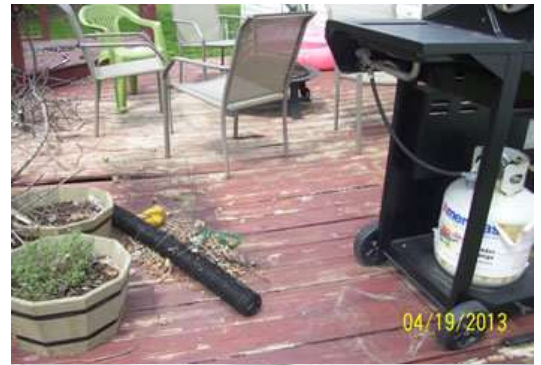
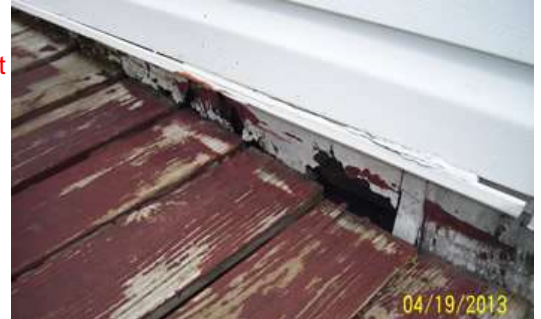
- Deck needs water treatment or repainting.
- Deck is uneven and in need of structural repair.
- Wood rot to trim and deck where deck meets home.

Suggest treating the deck with oil based, water repellent paint or preservative to protect and extend its remaining life. The deck is structurally unsound, it is uneven and sinks towards the middle; contact a licensed contractor to repair or replace the deck components until deck is structurally safe. The decking and house trim is suffering significant rot due to moisture where the deck meets the home

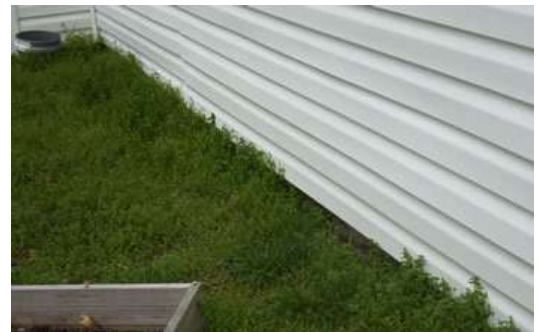
Trees, Grounds, and Shrubs

- Grass is growing past foundation into structure.

All vegetation should be cut down at least 6" under any wood structure to avoid insect infestation and moisture intrusion.

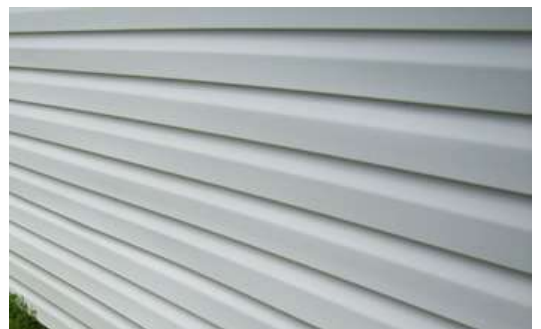
Condition: Serviceable

Type: Vinyl

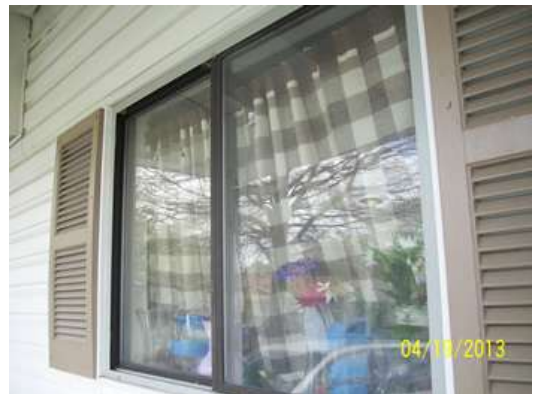
Windows do not have any storm windows installed, this is not a defect but storm windows improve energy efficiency particularly during the winter months.

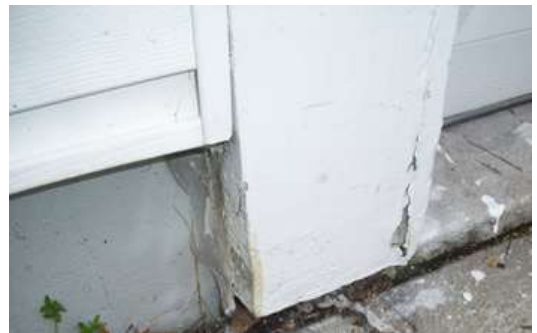
Exterior Trim

Many areas of the exterior trim need paint and caulk rehabilitation, including but not limited to the fascia boards and trim around the garage. All exterior surfaces should be kept well painted, stained, or sealed and all seams kept well caulked to prevent deterioration.

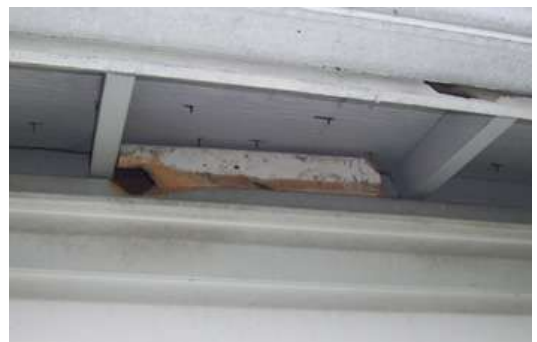
Eaves & Soffits

There is a hole observed in the eave at the back of the structure. This hole has been unprofessionally patched and should be permanently covered to prevent attic infestation.

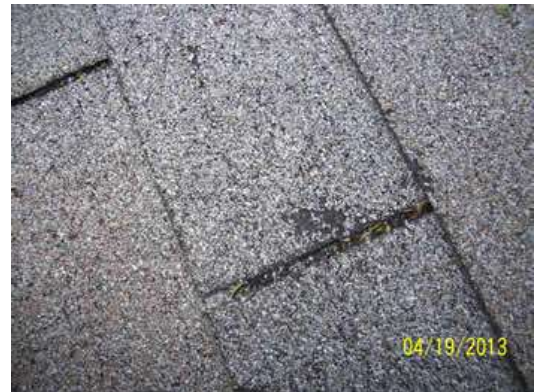
Roof shows normal wear for its age and type. No excessively damaged, deteriorated, or missing roofing materials were observed; the shingles appear to be in serviceable condition at the time of the inspection.

There is no drip edge installed on this roof, a drip edge is a metal flashing at the end of the eaves that protects the eave from water damage, the inspector suggests installing a metal drip edge on the roof.

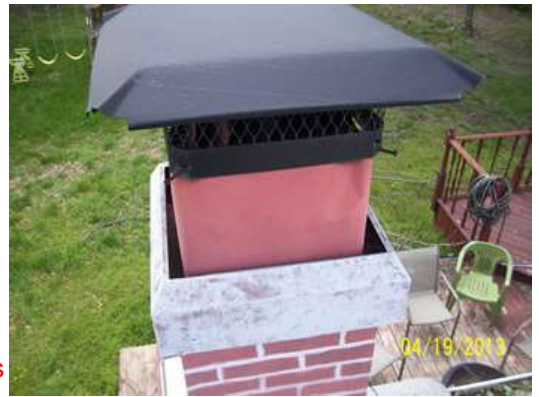
Examination of concealed / inaccessible portions of the chimney is beyond the scope of this inspection; this includes determining the presence of a flue lining. Home inspector advises not using the fireplace until the chimney can be cleaned and inspected by a qualified chimney sweep.

Suggest the client considers installing a cricket behind chimney to help shed water.

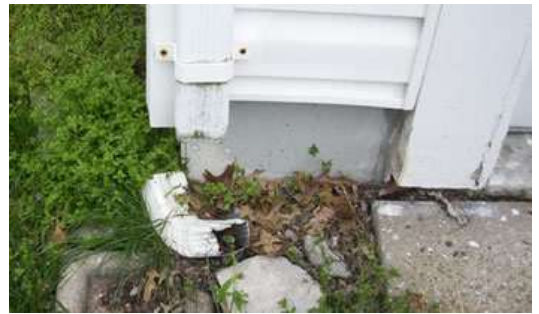
Gutters and Downspouts

- Downspout section is disconnected.
- Downspouts are not properly extended.
- Water damage to fascia from gutters leaking or overflowing.
- Gutters are filled with debris and should be cleaned.

Some downspouts are not properly extended away from the structure. Bottom elbow section of the front side downspout near the garage has come detached from its downspout.

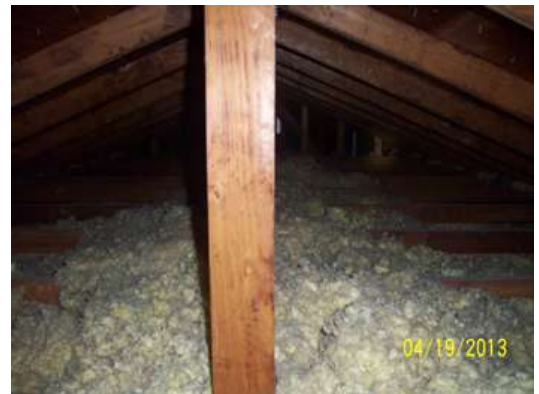
Condition: Satisfactory

Type: Conventional Framing

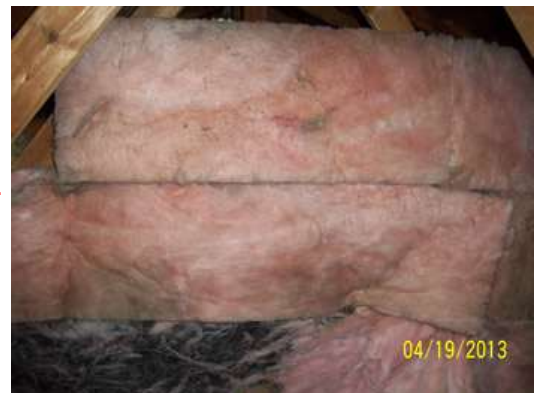
The residential side of the attic was unobservable due to being blocked by insulation batts taped against the framing blocking the path. Inspector recommends having this portion of the attic observed when this insulation can be removed.

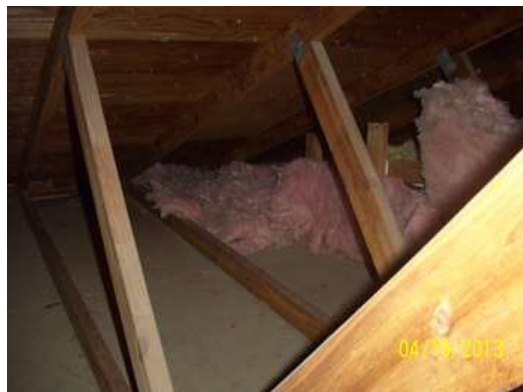
There is a hole in one of the eaves that is allowing an infestation into the attic. Once that hole is permanently patched up by a licensed contractor all damaged or disturbed insulation should be replaced.

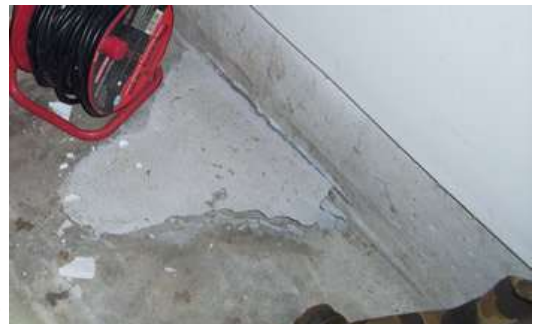
Patched areas in the floor are coming separated from the floor being patched; these areas should be removed and repatched. Garage also has cracks from age, Suggest sealing all concrete slab joints as well as any cracks in concrete/asphalt/brick surfaces to prevent water penetration as a routine maintenance effort.

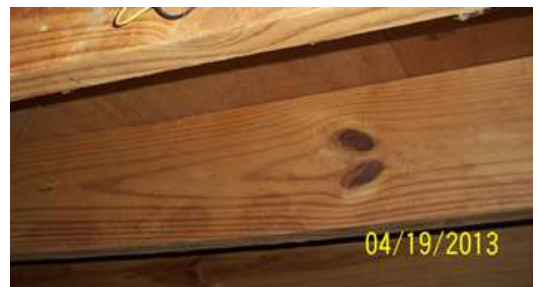
Limited view of both the floor joists and the sub flooring due to a large portion of the basement having finished ceilings. Client is advised to verify condition with the seller prior to close.

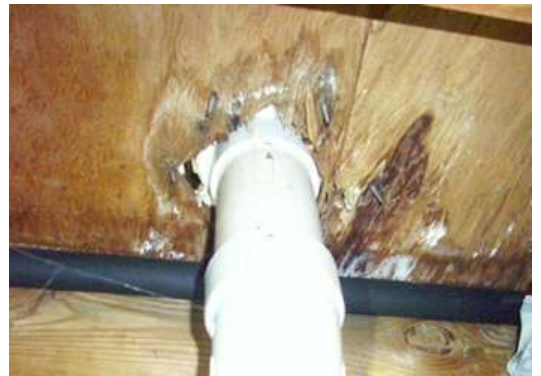
Basement Sub Flooring

- Evidence of water damage around plumbing drain.

There is water damage to the subfloor surrounding a plumbing drain. The plumbing drain belongs to the shower stall in the master bathroom. Inspector suggests a licensed plumber examine the shower stall concerning a possible leak underneath the shower pan.

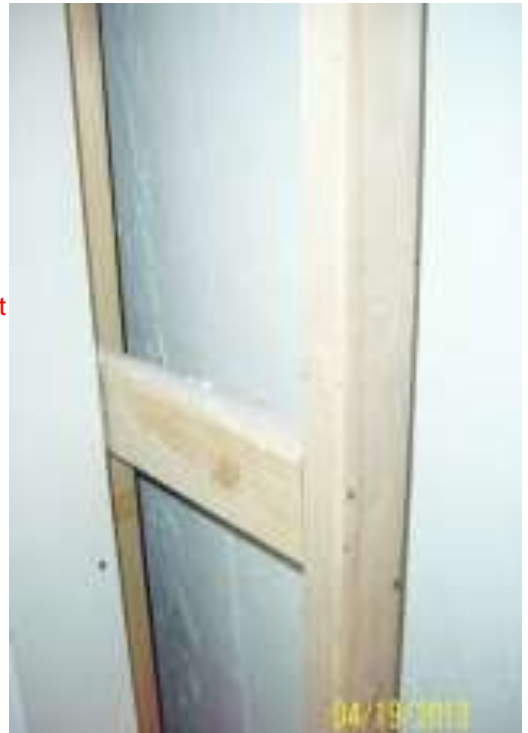
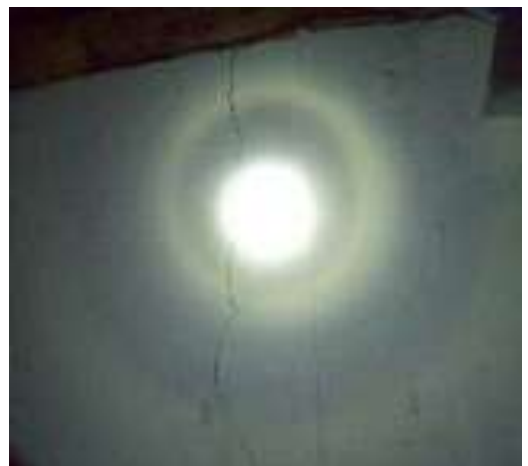
Basement Walls

- Vertical and diagonal cracks $>1/4"$ or pulling away.
- Significant leaning / bowing of foundation wall.

It is difficult to tell from the photos taken but the concrete basement wall is not plumb, the rear basement wall that is mostly closed in with drywall and framing is leaning inward towards the top. There are also some wide cracks both vertical and diagonal near a support beam on the other side of the structure. These symptoms could be signs of foundation failure, inspector recommends having the structure examined by a qualified engineer to determine any level of structural damage and instability as well as a suggested course of action to remedy the problem.

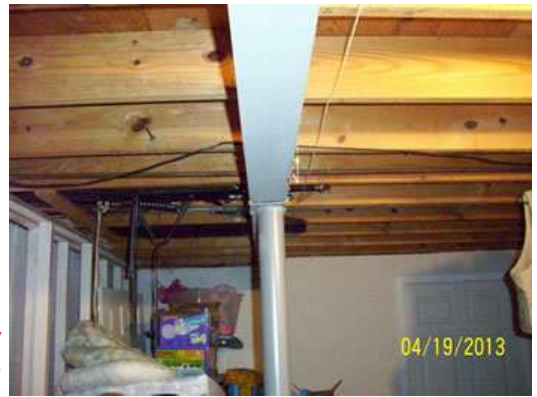
Basement Support Columns

Support columns and beams are leaning to one side. These symptoms could be signs of structural failure, inspector recommends having the structure examined by a qualified engineer to determine any level of structural damage and instability as well as a suggested course of action to remedy the problem.

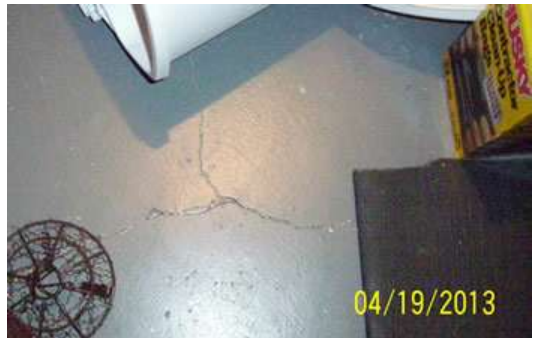
The greatest portion of the basement floor was covered by carpet and unavailable to inspect. The portion in the utility room had some shrinkage or movement cracking; inspector suggests these cracks be monitored.

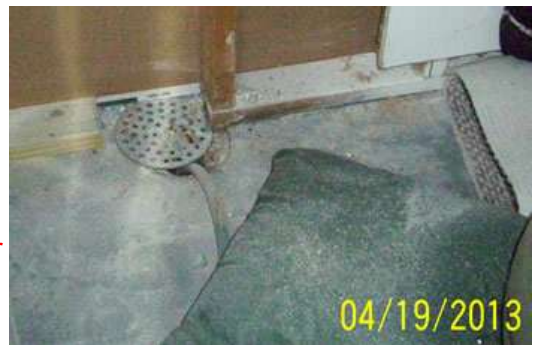
Floor Drain

Floor drain cover has been pushed aside to allow room for the condensate drain line from the air conditioner evaporator coil. Inspector recommends installing the AC drain line in such a way that the drain line goes through the drain cover while the cover is correctly attached.

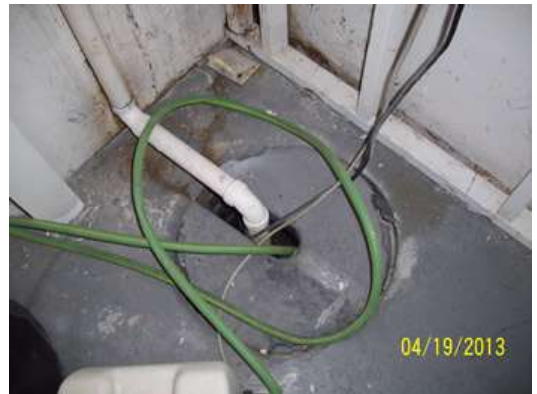
- GFCI circuit at sump pump.
- Moisture damage observed in sump pump surroundings.
- Hooked up to a humidifier with a hose.

The sump pump in the basement is using a GFCI outlet; these outlets are not recommended for sump pump use as the safety circuit would be likely to switch off when needed most.

There is moisture damage observed in the area around the sump where water has apparently leaked or overflowed.

There is a hose running from inside the sump to a humidifier, while the sump was not tested (no test button) the presence of the humidifier and surrounding moisture would suggest a rigged solution to a non-operational sump. The humidifier alone would not be efficient at emptying the sump and the moisture would also be released into the basement area causing other mildew, mold, and rot issues. Inspector suggests this sump be repaired or replaced by a licensed contractor.

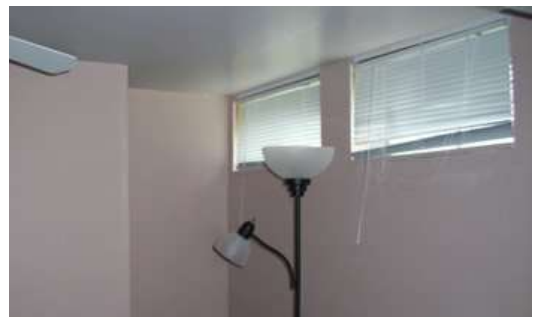
There are two basement windows located in a finished office space in the basement. Windows appear in good condition but were not tested due to obstruction.

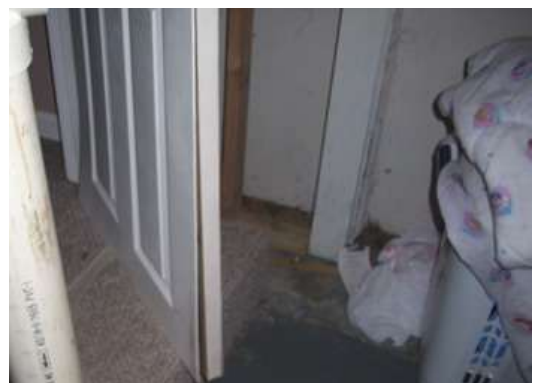
The door into the basement utility room interferes with the carpeted floor causing damage to the door. This could be due to improper installation of the door but is more likely a symptom of structural movement in the foundation. The door should be repaired or replaced by a licensed contractor.

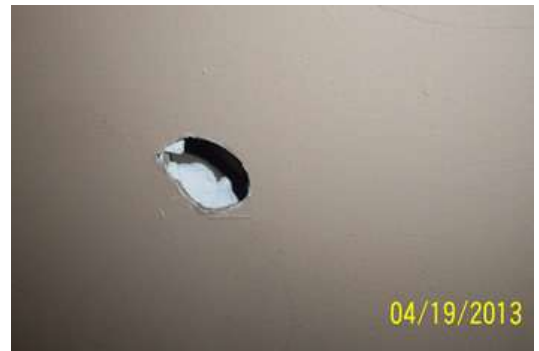
- Impact damage behind multiple doors.

There is impact damage behind several interior doors, including but not limited too; secondary and tertiary bedrooms and living room area. This damage is primarily cosmetic.

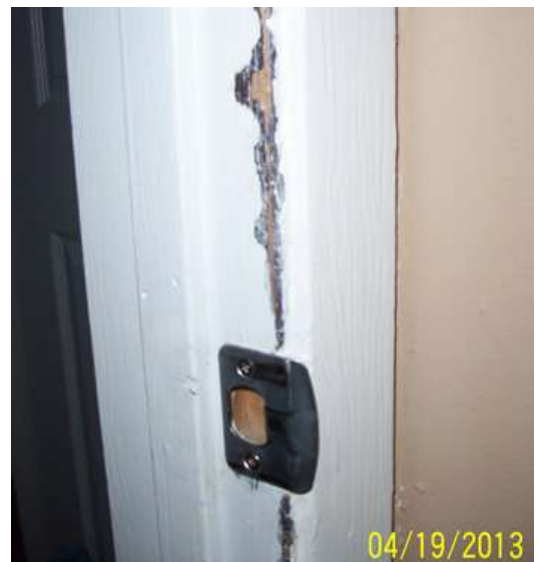
Interior Doors

- Secondary bedroom closet door off track.
- Several doors are out of plumb.
- Impact damage on door.

Many doors have impact damage behind the door from the door knob, and the closet door is off its track; these are primarily cosmetic concerns and relatively easy and inexpensive to fix by a qualified contractor.

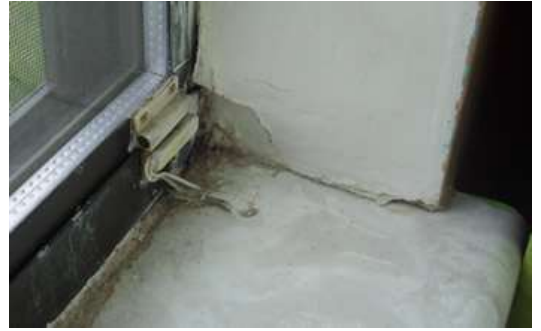
One bedroom window sill has some frame damage; this may be a sign of shear force caused by improper settlement and should be investigated by a qualified engineer along with other settlement symptoms of the home.

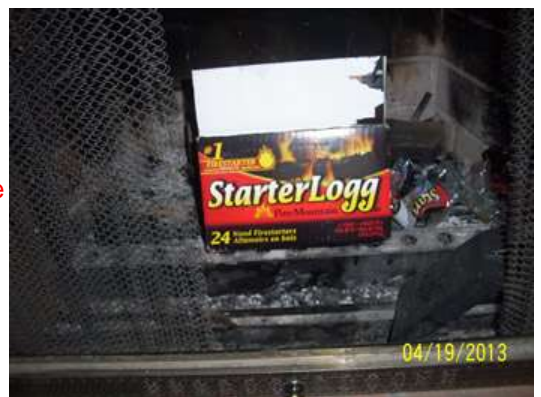
This is a limited review of the fireplace, flue, and flue lining. We are unable to view the walls or flue lining for cracks, holes, creosote, or other damage or deterioration. With all wood fireplaces we suggest professional cleaning and inspection of the fireplace, flue, and flue lining be performed to ensure the system is in proper and safe condition before use.

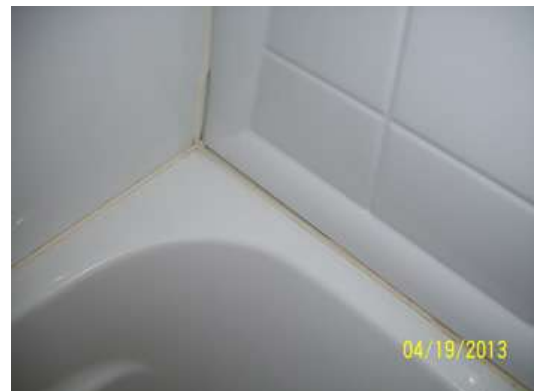
The Caulk sealing the bathtub and shower walls in the hallway bathroom is coming separated and should be rehabilitated. Failure to keep walls sealed can cause deterioration and moisture damage to the interior walls, which is not always visible to the inspector at the time of the inspection.

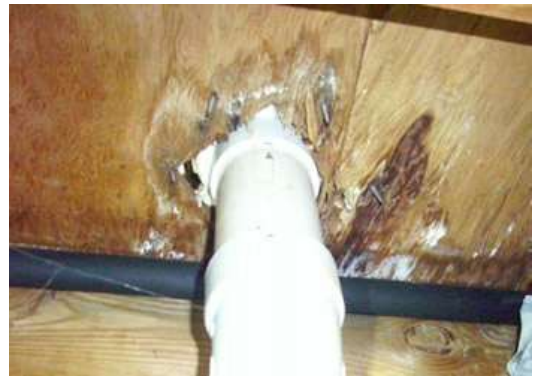
Shower Stall

- Mildew present in shower stall area.
- Shower stall door doesn't open and close properly.
- Water damage present on subfloor below shower stall.
- Caulk at shower stall and floor junction needs rehabilitation.

The shower stall door is not properly aligned with the frame and doesn't close properly; this may be due to improper installation, damage, or settlement of the structure. This along with other settlement symptoms should be examined by a qualified structural engineer.

There is water damage present on the sub floor panels directly below the shower stall, inspector recommends a licensed plumber examine the shower pan to repair any possible leaks and damage.

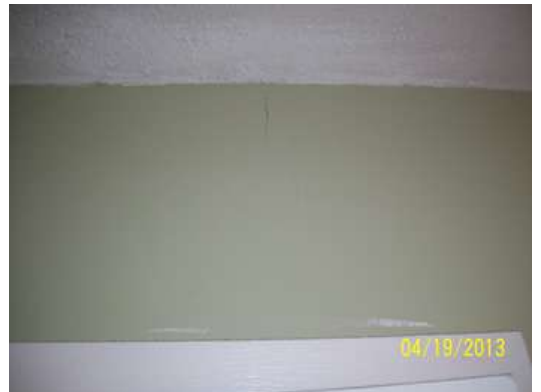
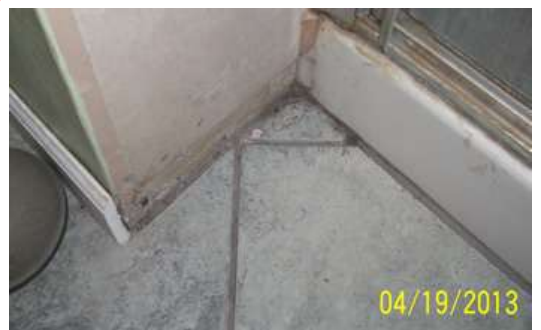
- Unfilled screw holes in wall.
- Small crack above door.
- Missing baseboard near shower stall.

There are some observed unfilled holes in the bathroom walls and a small crack above the door, these problems are primarily cosmetic. The crack above the door may possibly be another symptom of structural failure and should be examined along with any other signs by a licensed structural engineer. There is a baseboard missing near the shower stall, this should be replaced not only for cosmetic purposes but also to help prevent moisture penetration to the floor below.

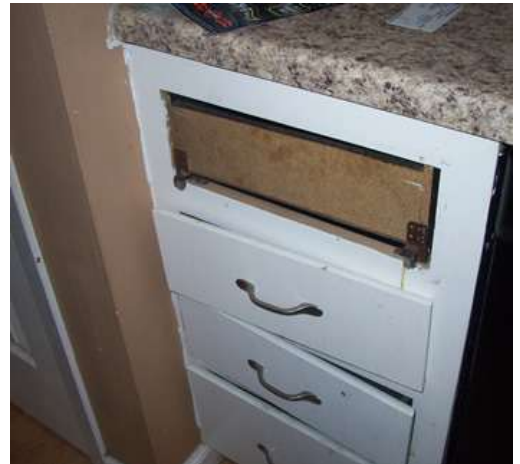
- Some drawers are missing covers.
- Some drawers don't operate smoothly.

A representative number of drawers were tested. One drawer was noticed that was missing its cover panel entirely and several would not slide or operate smoothly.

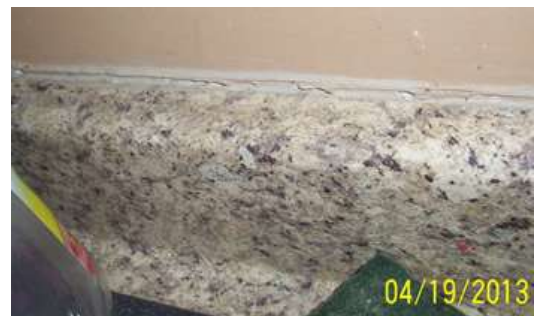
- Caulk around counter top is cracking and needs rehabilitation.

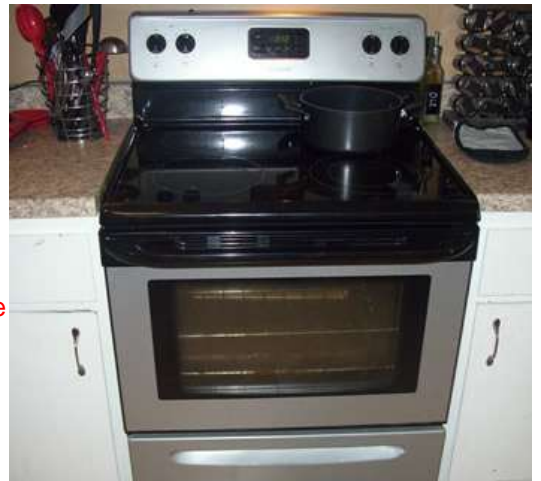
Stove top elements and the oven were tested at the time of the inspection and appeared to function properly. These can fail at any time without warning. No warranty, guarantee, or certification is given as to future failure.

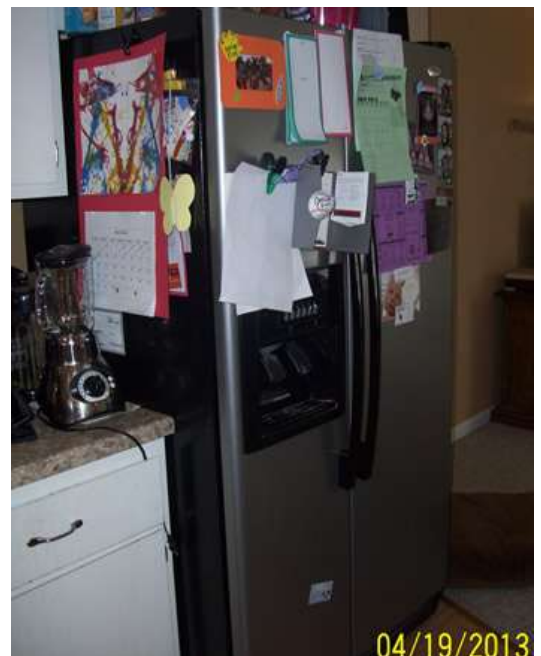
The refrigerator appeared to be serviceable and was inspected to verify that unit is cooling at the time of inspection. Freon levels, icemaker operation and other specialty items are beyond the scope of this inspection, recommend consulting sellers for additional information.

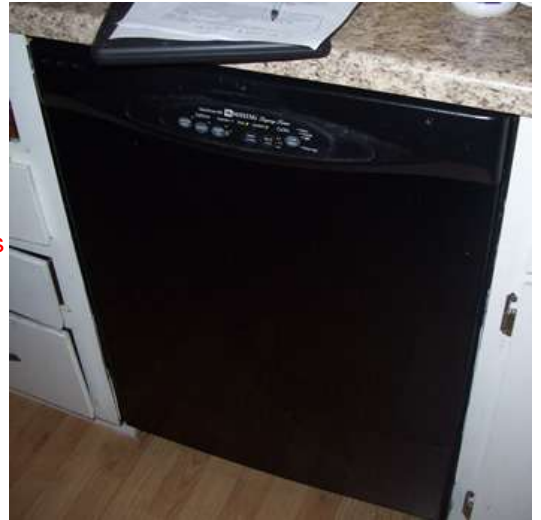
Dishwasher was operational at the time of inspection. Dishwashers most commonly fail internally at the pump, motor, or seals. We do not disassemble these units to inspect these components. Our inspection is limited to operating the unit on the 'normal wash' cycle only. We recommend you operate this unit prior to closing.

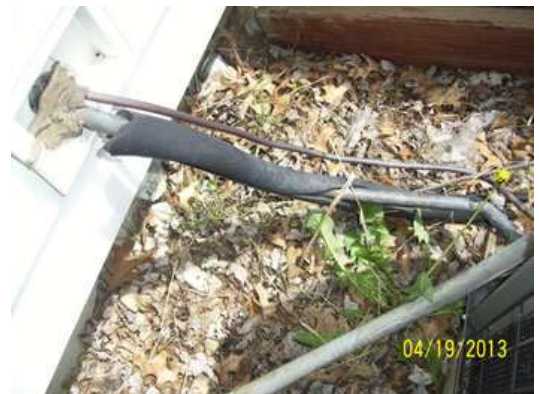
Condition: Satisfactory

Location: Near AC Unit

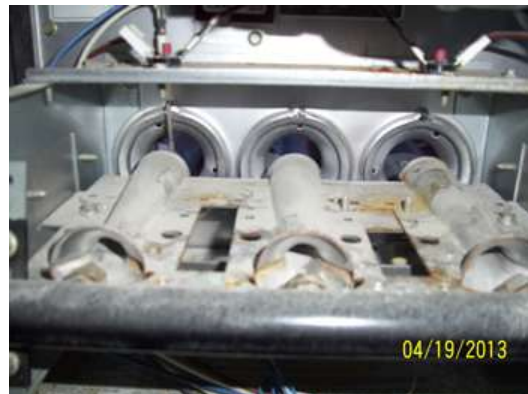
The heating system was tested using normal operating controls and appeared to function properly at time of inspection. Due to inaccessibility of many of the components of this unit, the review is limited. Holes or cracks in the heat exchanger are not within the scope of this inspection as heat exchangers are not visible or accessible to the inspector. As with all mechanical equipment the unit can fail at any time without warning. Inspectors cannot determine future failures. If a detailed inspection is desired, a licensed heating contractor should be consulted prior to closing to ensure proper and safe operation of this unit.

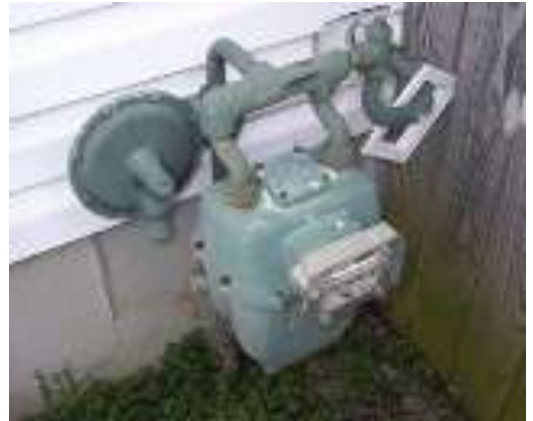
Gas line entering the home should be re-caulked at the entry point to prevent moisture or insect penetration.

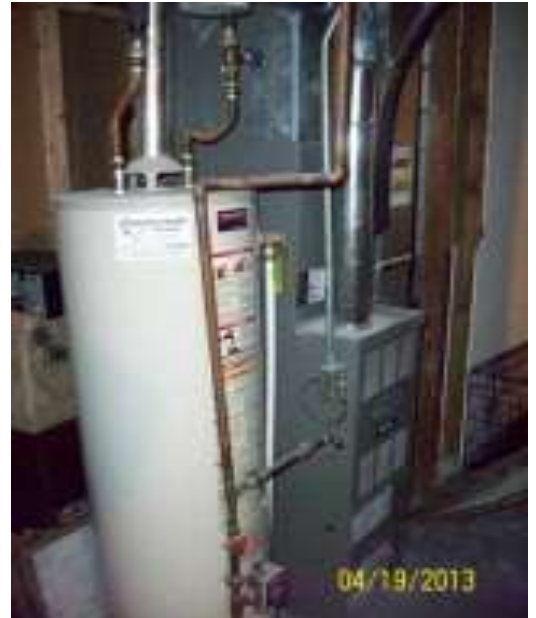
Temperature pressure relief valves are not operated. We recommend testing the valve after arrangements are made for the water flow. If the valve does not operate as intended, we recommend any repairs necessary to assure that the valve can operate under high temp/pressure conditions.

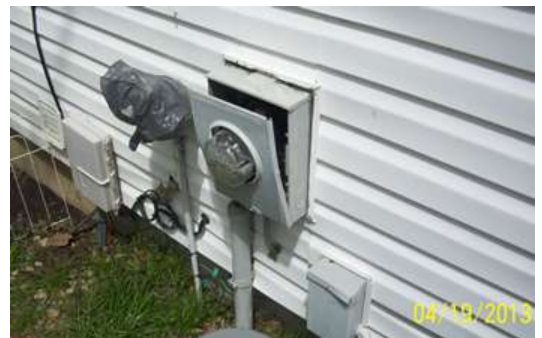
The electric service box is open and unsecure, recommend contacting a licensed electrician to close and re-secure the service box.

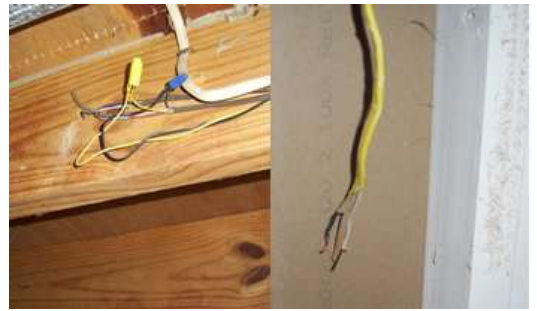
- There is an electrical connection made outside of junction box.
- Unconnected wiring in basement area.
- No power to garage circuit.
- Master bedroom closet light did not operate.
