# Home Inspection Report

**Year Constructed:** 1971  
**Square Feet:** 1800  
**Type:** Single Family Home  
**Bedrooms:** 4  
**Bathrooms:** 3

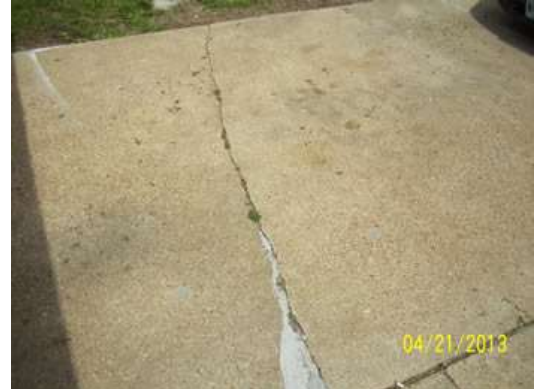
## Driveway

**Condition:** Needs Maintenance

The driveway was partially obstructed by vehicles during the inspection. From what was seen the driveway has several common cracks typical for its age; this is primarily a cosmetic condition. Separation of some cracks can create trip hazards that are potentially dangerous. The inspector suggests sealing all cracks to prevent moisture penetration and reduce the rate of further deterioration.

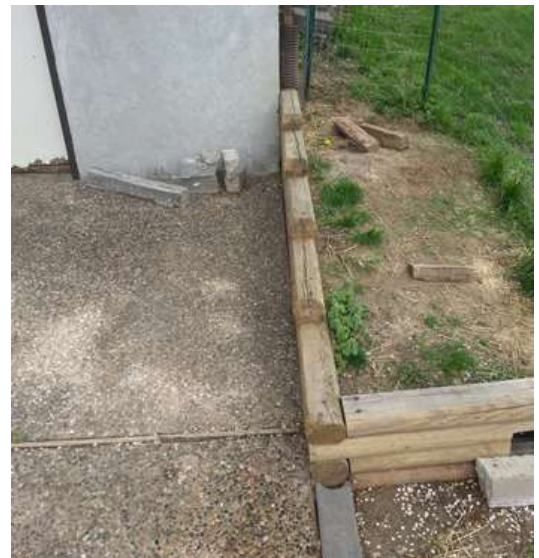
## Retaining Wall (Back)

**Condition:** Not Satisfactory

There is a small retaining wall near the back patio that is leaning outward. Hydrostatic pressure from moisture buildup in the earth can push retaining walls outward if proper strength and drainage are not provided. This wall should be monitored closely and if it progresses outward or fails it should be restructured by a licensed contractor.

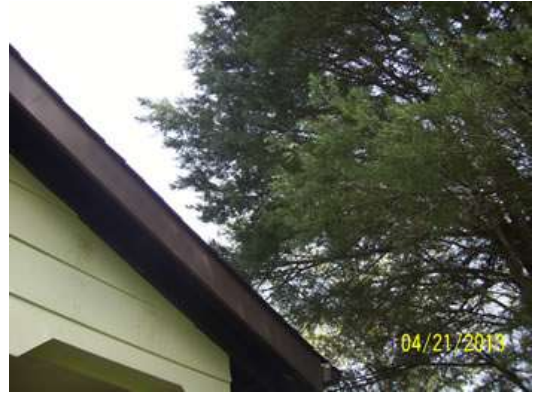
The tree in the front of the home is growing over the roof structure and should be cut back and maintained.

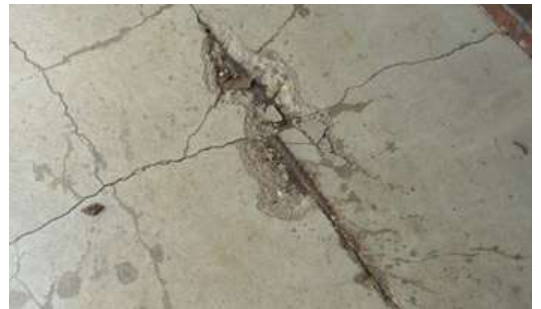
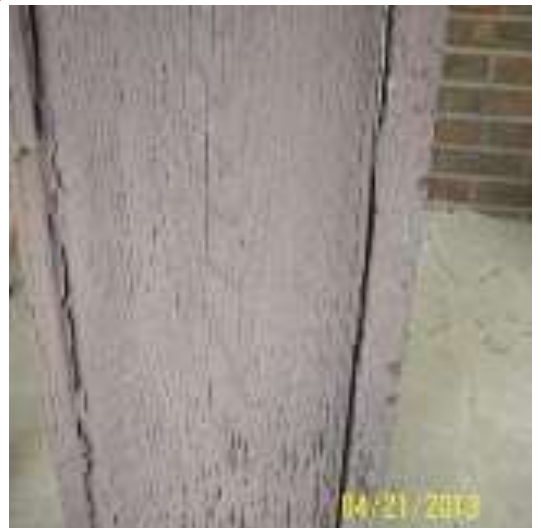
- Significant cracks in concrete, rebar protruding.
- Porch columns need paint and caulk rehabilitation.

Front concrete porch has significant cracks with rebar protruding in multiple areas; in addition to being cosmetically undesirable this is a tripping hazard that will likely continue to get worse over time. If installation of a new concrete porch is not viable recommend all concrete cracks be sealed to slow further deterioration. Porch columns have moisture damage and are in need of typical paint and caulk rehabilitation to prevent further moisture penetration to the wood.

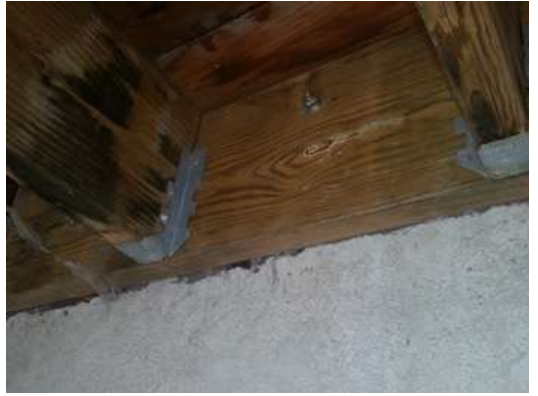
Suggest treating with oil based water repellant preservative, paint, or stain to protect and extend the remaining life of the deck. No flashing exists between structure and deck, this is allowed in some municipalities but not in others, we recommend reviewing local standards for safety and compliance.

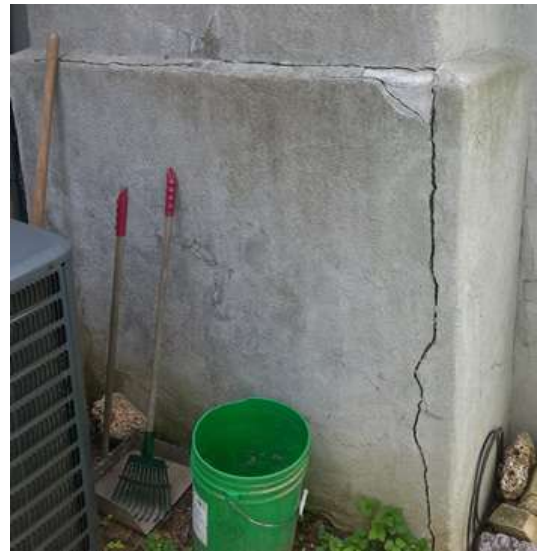
## Exterior Foundation

- 1 shrinkage crack found near porch.
- Cracks in concrete around chimney.

There are cracks in the concrete around the chimney area these cracks should be evaluated by a licensed contractor for repair.

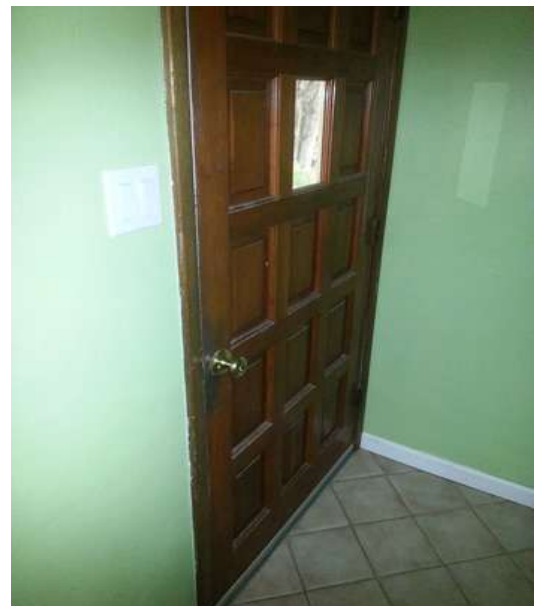
The front door is slightly less than 36 inches wide, recent codes require a minimum of 36 inch width on exterior doors for ease of moving furniture in and out, this code did not apply when this home was constructed. There is no deadbolt lock on the front door, the inspector recommends installing a dead bolt for safety.

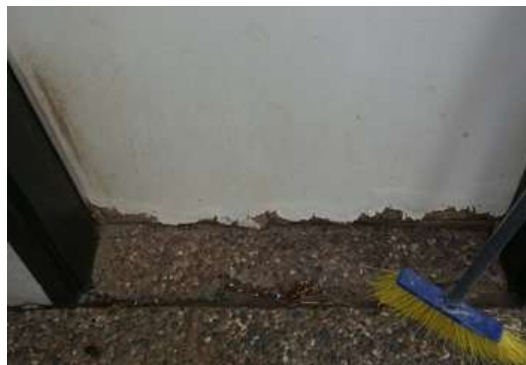
## Exterior Door

- Low area where water can stand near door.
- Significant water damage to the bottom of door.

The threshold of the lower level rear exterior door is a low area where water can pool; the water retention there is causing damage to the bottom of the door. Contact a licensed contractor about possible solutions to this problem.

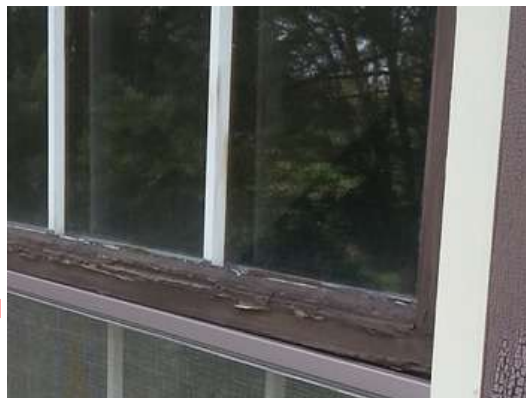
## Exterior Windows

Many or all of the exterior windows have peeling paint and caulk. All exterior surfaces should be kept well painted, stained, or sealed and all seams kept well caulked to prevent deterioration.

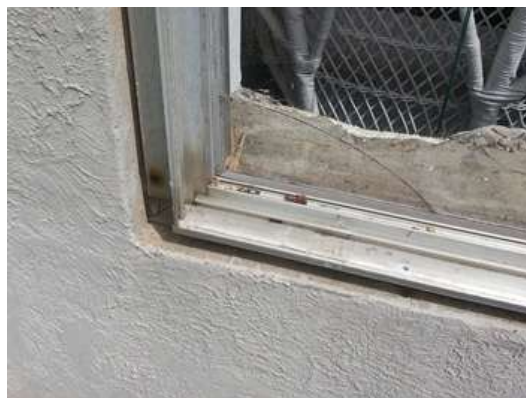
## Exterior Windows (Back)

- Windows in need of paint and caulk rehabilitation.
- There is a crack in the glass panel.

Back downstairs window has a crack in the glass; this glass pane will need to be replaced by a licensed contractor. Many or all of the exterior windows have peeling paint and caulk. All exterior surfaces should be kept well painted, stained, or sealed and all seams kept well caulked to prevent deterioration.

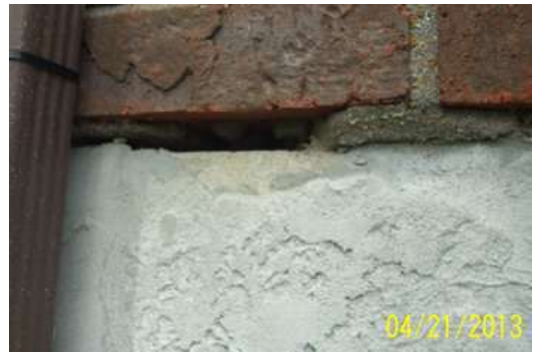
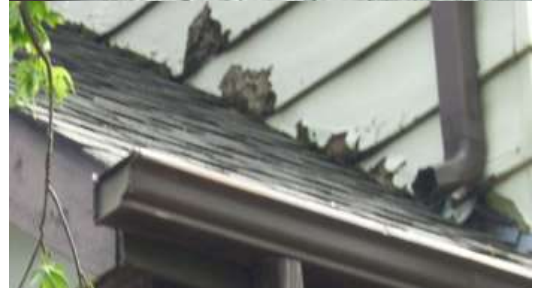
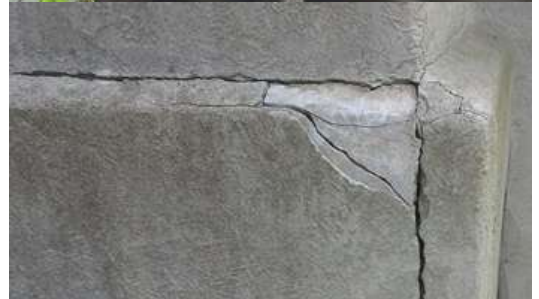
- Mortar missing in several sections.
- Water damage where wood siding meets roof.
- Cracks in wall concrete wall covering around chimney.

Mortar is missing in several areas where the concrete meets the brick wall; this mortar should be filled in. There is significant moisture damage where the wood siding meets the roof, these siding boards should be replaced and well flashed. There are cracks in the concrete around the chimney area these cracks should be evaluated by a licensed contractor for repair. All exterior surfaces should be kept well painted, stained, or sealed and all seams kept well caulked to prevent deterioration.

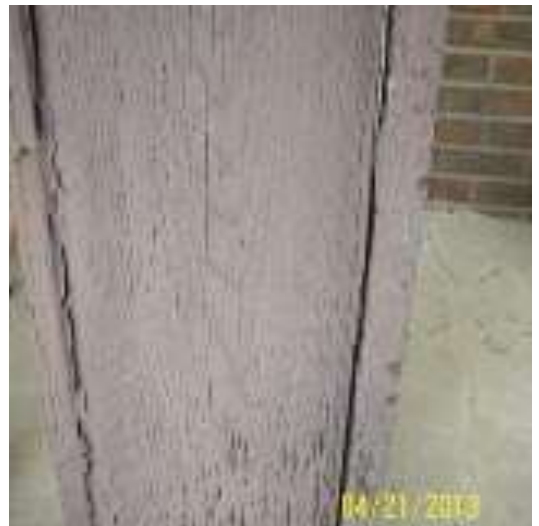
## Exterior Columns

Porch columns have moisture damage and are in need of typical paint and caulk rehabilitation to prevent further moisture penetration to the wood. All exterior surfaces should be kept well painted, stained, or sealed and all seams kept well caulked to prevent deterioration.

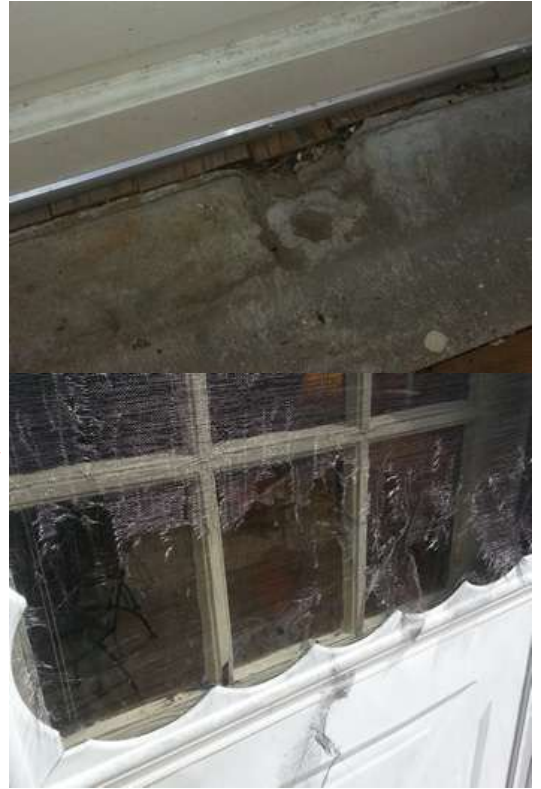
- Framing around window sash has moisture damage.
- Concrete threshold landing chipped.
- Trim needs paint and caulk rehabilitation.
- Metal storm door does not close properly.
- Metal storm door screen is ripped.

All paint and caulk on door, trim, and threshold should be rehabilitated to prevent further moisture damage. The metal storm door does not close and has a ripped screen, the concrete entry way has a large chip in it; these defects should be evaluated by a licensed contractor about repair or replacement of the screen door and concrete.

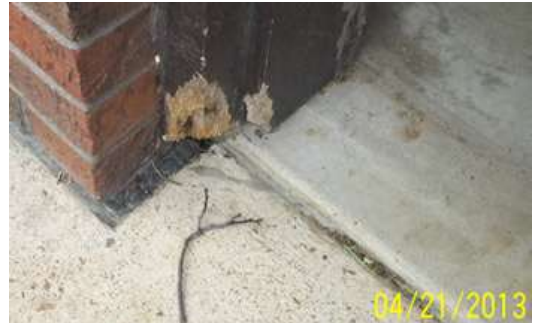
## Exterior Trim

- Some trim in need of caulk and paint rehabilitation.
- Damage near driveway at garage door.

Trim around the garage door is damaged near the ground level, damage appears to be impact damage and should be repaired or at a minimum sealed with paint to prevent moisture intrusion into the wood. All exterior surfaces should be kept well painted, stained, or sealed and all seams kept well caulked to prevent deterioration.

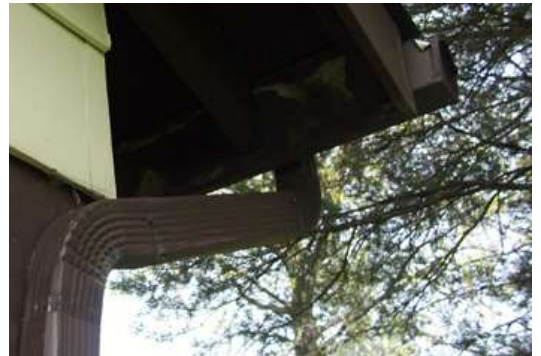
## Eaves & Soffits

- Water damage on fascia boards

There is water damage on the fascia boards behind the gutters. This moisture is likely a cause of gutters that aren't cleaned often or properly and are backing up water onto the fascia. The fascia should be sealed with paint to prevent further damage and gutters should be properly maintained.

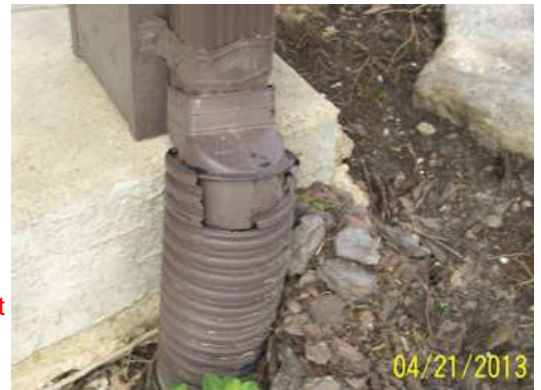
## Downspouts

- Plastic underground extensions are cracked.

The plastic extensions that connect to the downspouts are cracked at the connection point; this could be allowing water to leak out near the foundation.

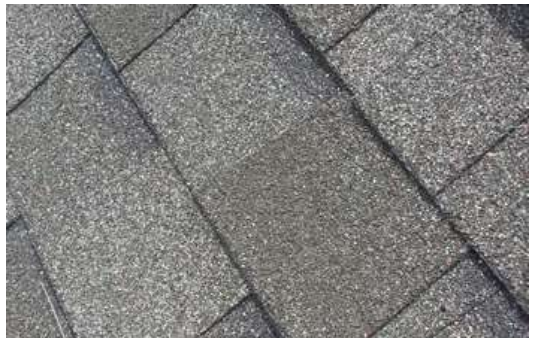
Roof shows normal wear for its age and type. Minor erosion, no damaged, deteriorated, or missing roofing materials were observed; it appears to be in serviceable condition at time of inspection.

Many insurance companies inspect roofs prior to agreeing to provide coverage. We recommend that you arrange any such inspection prior to closing to help assure a smooth transition between old and new insurers.

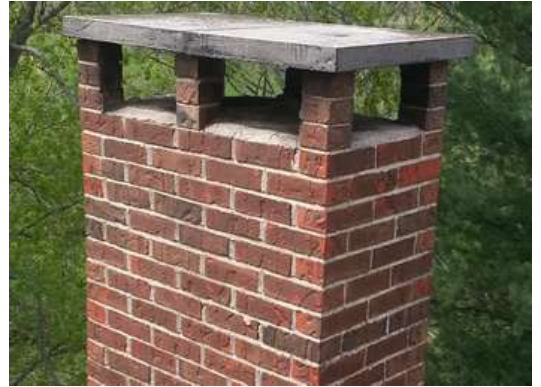
Suggest client consider installing a spark arrestor to enhance fire safety. Suggest client consider installing a cricket behind chimney to help shed water.

Examination of concealed / inaccessible portions of the chimney is beyond the scope of this inspection. This includes determining the presence of a flue lining.

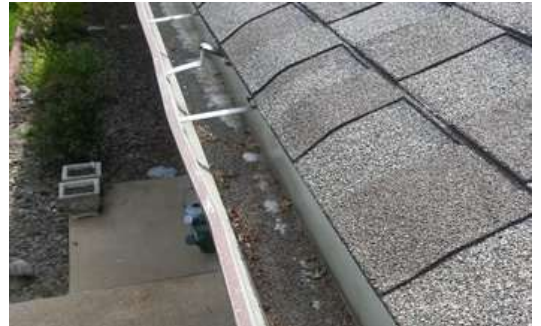
Some granules in gutters from asphalt shingle deterioration. Gutters are sufficiently cleaned out at time of inspection.

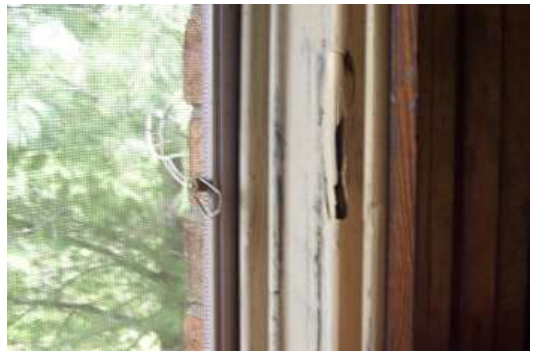
- Loose and cracked window framing.

Framing around window is loose and cracked, window operates and locks smoothly.

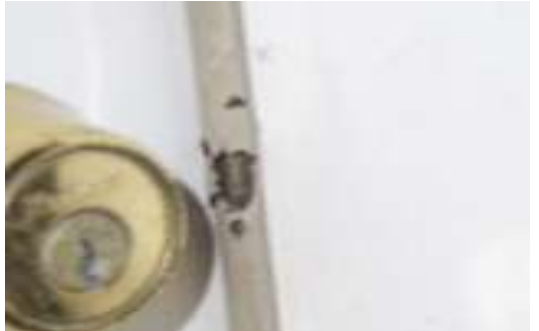
## Door to Living Space

- Door weather stripping is cracked and brittle.

No self-closer was observed on the door between the garage and living space. Inspector suggests installing a self-closer as a safety measure.

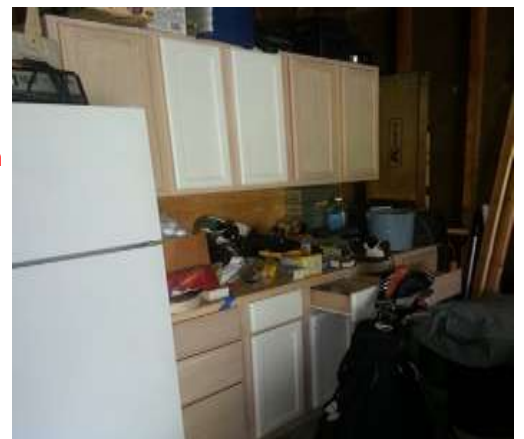
Inspector tested a representative number of drawers and cabinets in the garage and all tested operated properly. Some cabinets and drawers were a different color than others, this is purely cosmetic.

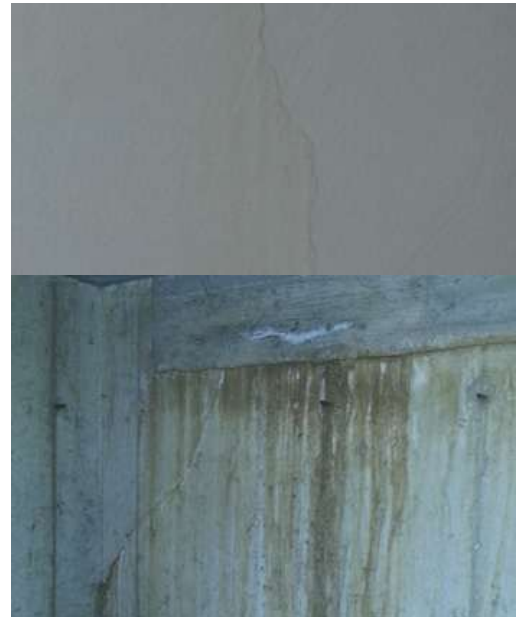
## Foundation

- Small shrinkage cracks with moisture penetration.
- Moisture penetration where slabs meet under garage.

Moisture is penetrating through some small shrinkage cracks and at select concrete slab joints in the basement walls. Cracks of this size aren't typically considered a problem unless moisture is penetrating, all cracks should be sealed over to avoid moisture from getting into the basement.

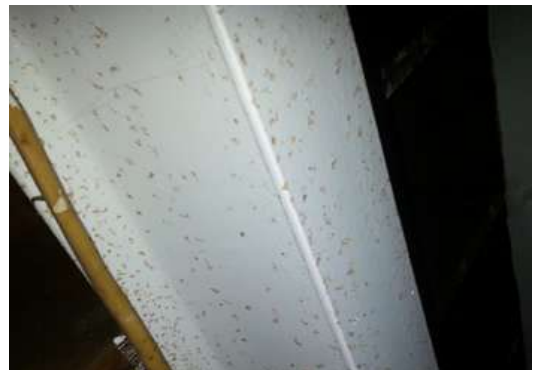
## Basement Support Columns

- Rust spots on steel support beams.

Small rust spots are showing on the steel support column. This is likely caused from moisture condensing on the cold steel. Posts need paint rehabilitation and well maintained paint covering on steel at all times to prevent rust.

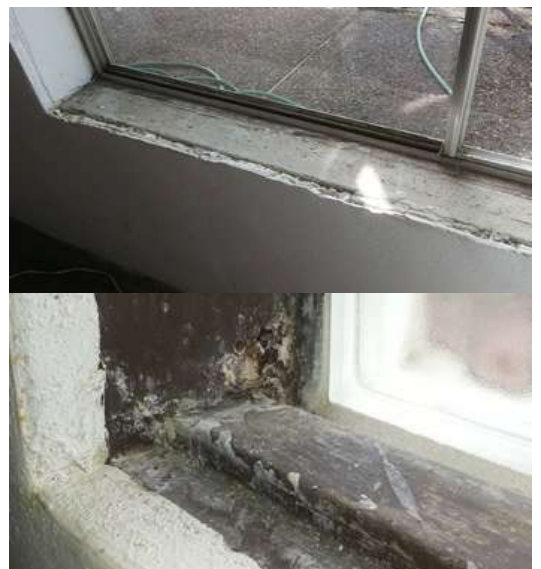
- One basement window is cracked.
- Framing on one window sill is exposed.
- Rust observed in window framing.

Large sliding window in basement has a small crack in the glass and has no covering on the window sill. Other basement windows are showing signs of rust in window framing and should be sealed with paint to prevent further deterioration.

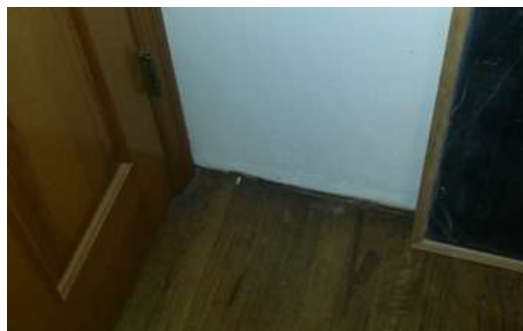
## Interior Walls And Ceilings

- Missing baseboards in several rooms.

Upstairs left bedroom is missing some baseboards; main floor bedroom is missing baseboard and has no baseboards in the closet.

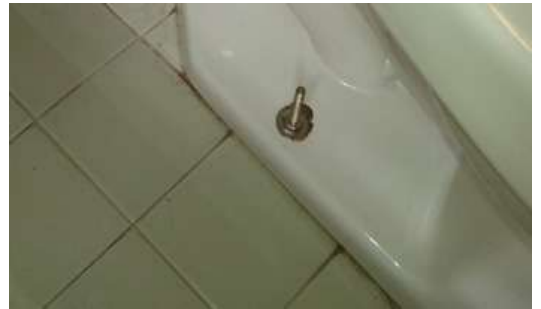
Toilets should be sealed to the floor with well-maintained caulk to prevent moisture from seeping under the toilet.

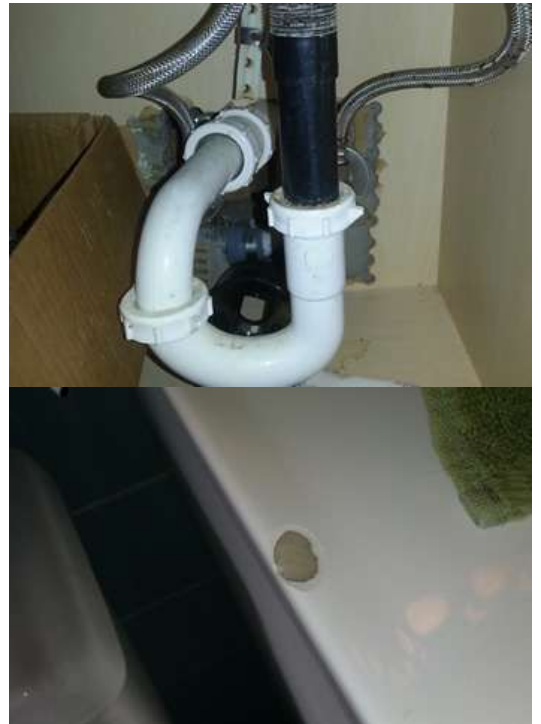
## Sinks

- Main floor and upstairs bathrooms have poor drainage.
- Large opening in plaster under sink exposing wall.
- Cosmetic nick in sink top and cosmetic damage under sink.

There is a large opening in the plaster under the sink that should be patched up. This sink also has a large nick in the side (cosmetic problem only). There is some cosmetic damage to the cabinet area under the basement sink.

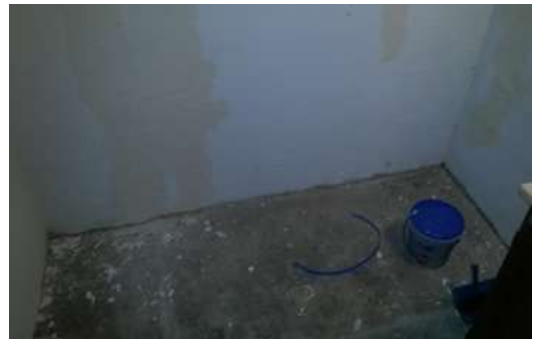
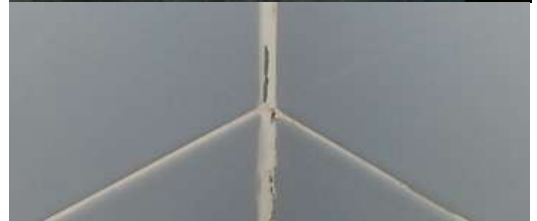
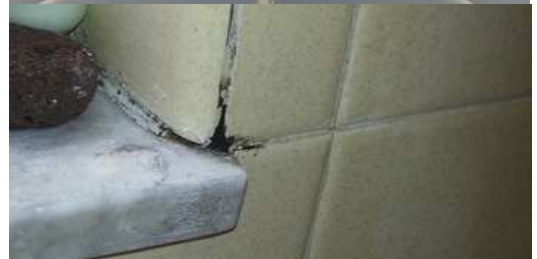
## Bathtub

Basement bathroom shower is clearly in an unfinished state, there is no functioning walls or shower floor. A shower drain and supply faucet are visibly present but neither were tested.

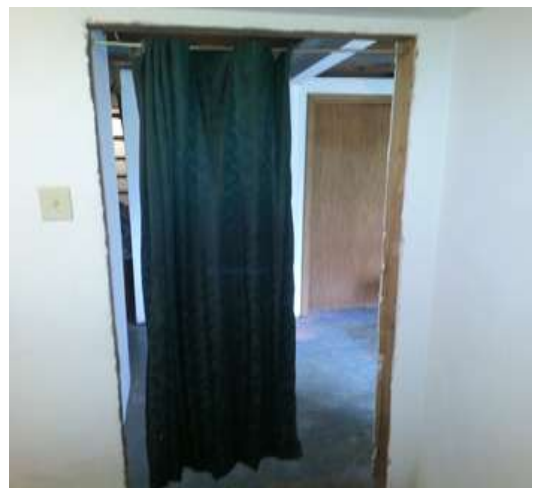
Basement bathroom is in an unfinished state, there is no door installed, sliding curtain installed for privacy.

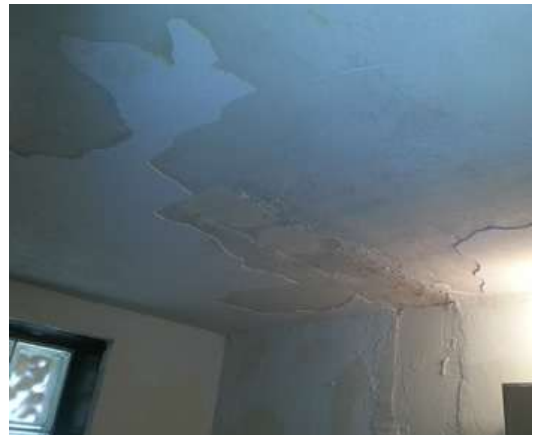
Finish plaster on the basement bathroom walls and ceilings is failing. This is a clearly unfinished bathroom which requires significant work before being up to code.

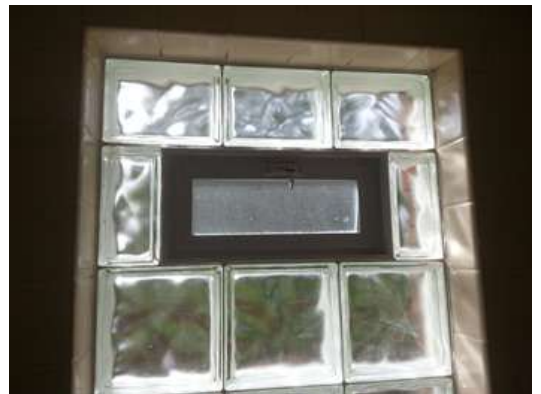
Window opening in bathroom is very small and allows for very little ventilation of moisture, suggest adding a ventilation fan to help reduce the possibility of moisture damage in the bathroom.

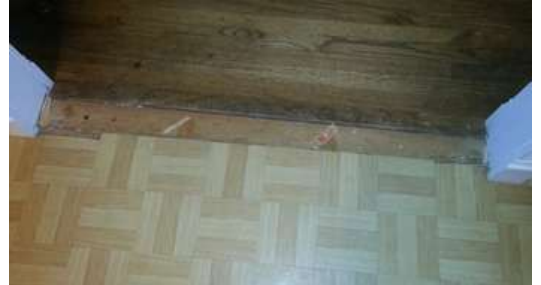
The border floor piece that covers the transition between the kitchen linoleum floor and wood dining room floor is missing. This is primarily a cosmetic concern but could also be a trip hazard; suggest adding a new transition piece.

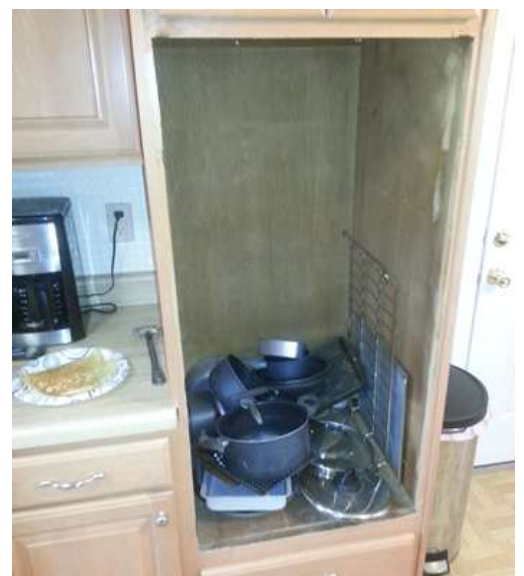
Representative number of cabinets and drawers were tested, all tested operated smoothly. There are some drawers and doors missing entirely where there is a large empty space and will need to be replaced in this area.

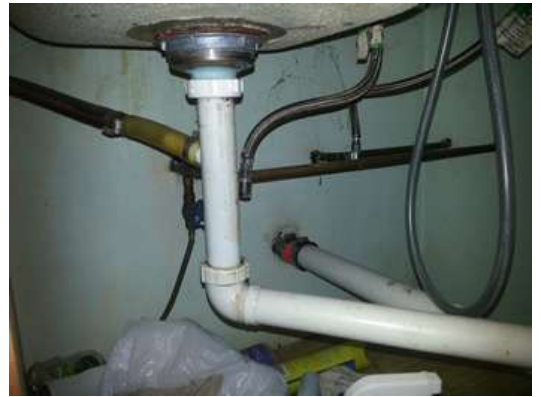
Limited review due to personal property stored under sink cabinet. Client is advised to consult with sellers for additional information prior to close. Flow and drainage were serviceable at the time of inspection. There is no shut off valve present on the kitchen sink, if this utility needs to be shut off for any reason the main water line will need to be shut off, the inspector suggests having a licensed plumber add a shut off valve.

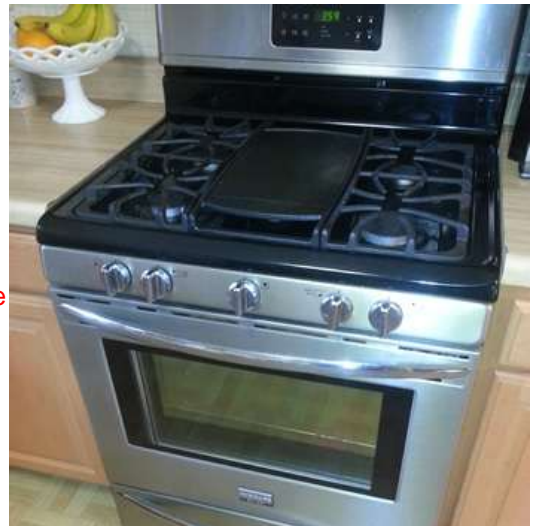
Stove top elements and the oven were tested at the time of the inspection and appeared to function properly. These can fail at any time without warning. No warranty, guarantee, or certification is given as to future failure.

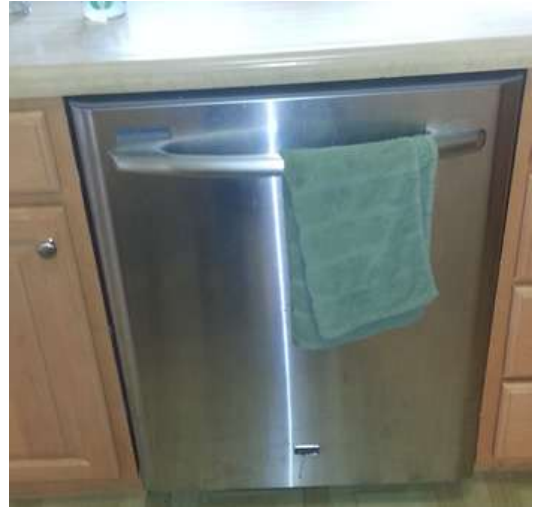
Dishwasher was operational at the time of inspection. Dishwashers most commonly fail internally at the pump, motor, or seals. We do not disassemble these units to inspect these components. Our inspection is limited to operating the unit on the 'normal wash' cycle only. We recommend you operate this unit prior to closing.

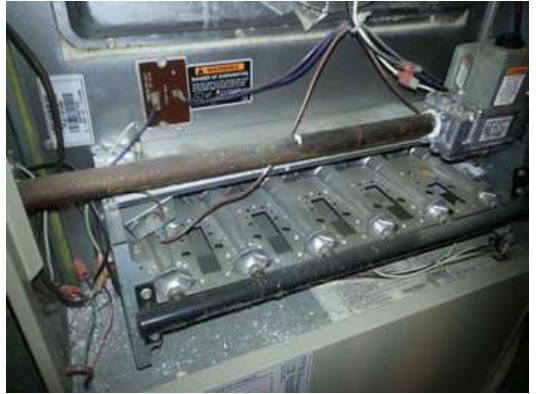
The heating system was tested using normal operating controls and appeared to function properly at time of inspection. Due to inaccessibility of many of the components of this unit, the review is limited. Holes or cracks in the heat exchanger are not within the scope of this inspection as heat exchangers are not visible or accessible to the inspector. As with all mechanical equipment the unit can fail at any time without warning. Inspectors cannot determine future failures. If a detailed inspection is desired, a licensed heating contractor should be consulted prior to closing to ensure proper and safe operation of this unit.

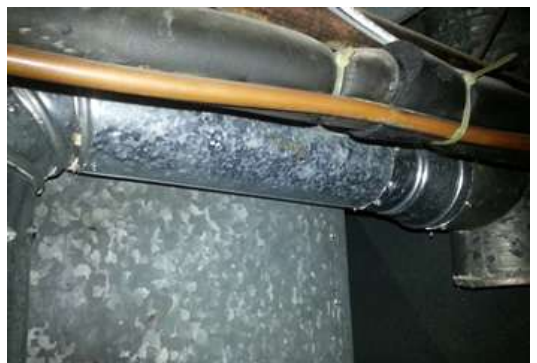
There is a slight negative slope on the combustion ventilation duct; this ventilation duct should be re aligned by a licensed contractor so that it has a positive rising slope of at least an inch per foot.

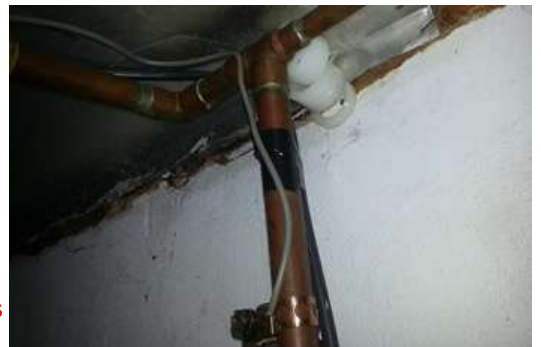
## Pipes

The supply pipe is held away from the wall using plastic shims, this pipe should be supported with a proper bracket and the rigged up plastic shims should be removed.

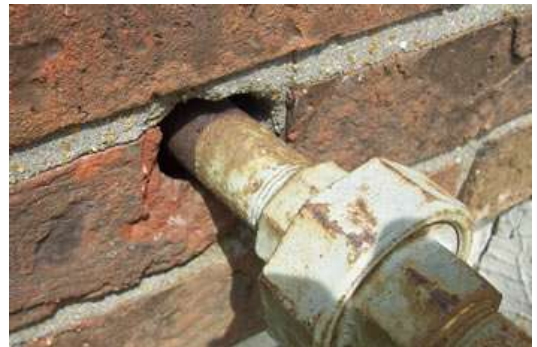
## Gas Meter and Piping

The point where gas plumbing enters the home should be well sealed with caulking compound to prevent pest or moisture penetration. The caulk at the gas meter appears to have been removed or never added and needs rehabilitation.

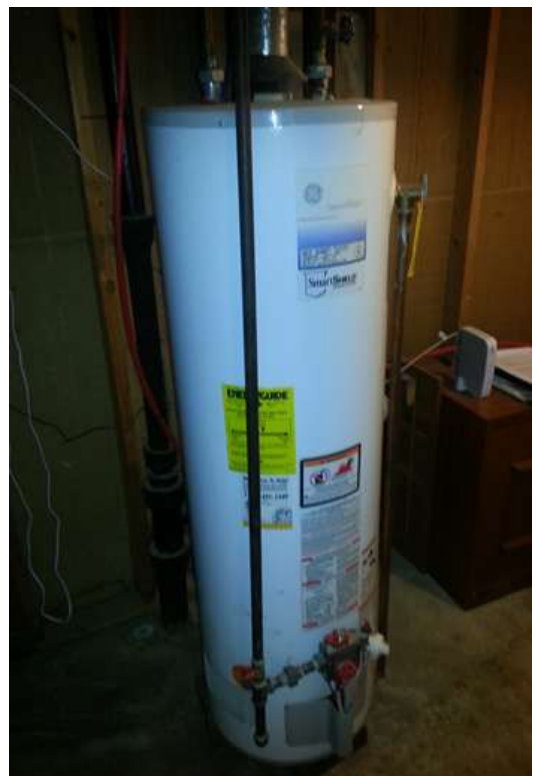
Temperature pressure relief valves are not operated. We recommend testing the valve after arrangements are made for the water flow. If the valve does not operate as intended, we recommend any repairs necessary to assure that the valve can operate under high temp/pressure conditions.

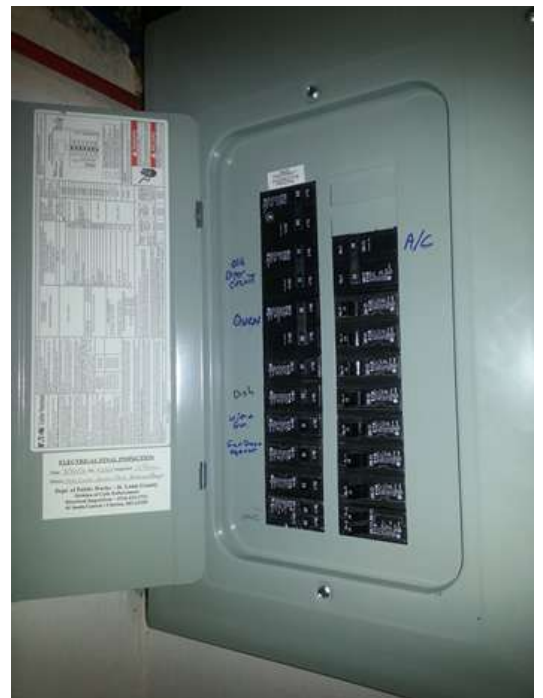
Circuits are labeled poorly with only a few labels. The home inspector recommends a licensed electrician trace the branch circuits and labels them appropriately.

Service cables are aluminum; Branch wiring is copper. This is the most typical application of residential wiring.
